Full-Scale Testing of Thermoplastic Composite I-Beams for Bridges

Ghassan K. Al-Chaar, Steven C. Sweeney, Richard G. Lampo,
and Marion L. Banko

June 2017

Final report

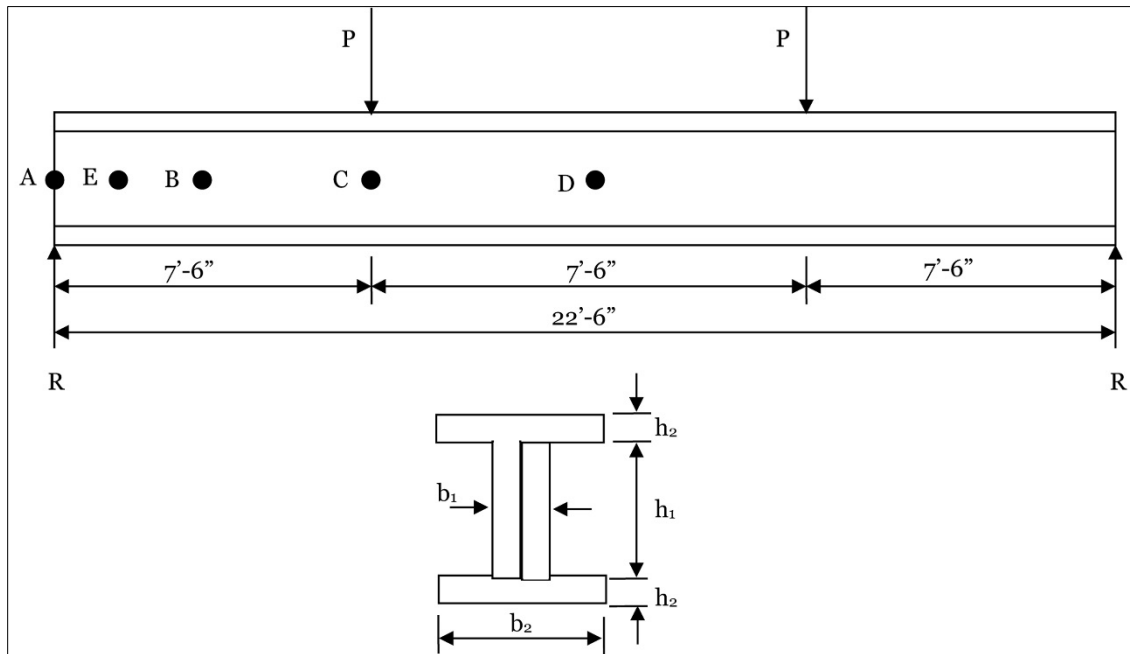
Figure 3. Nominal beam dimensions (not to scale).

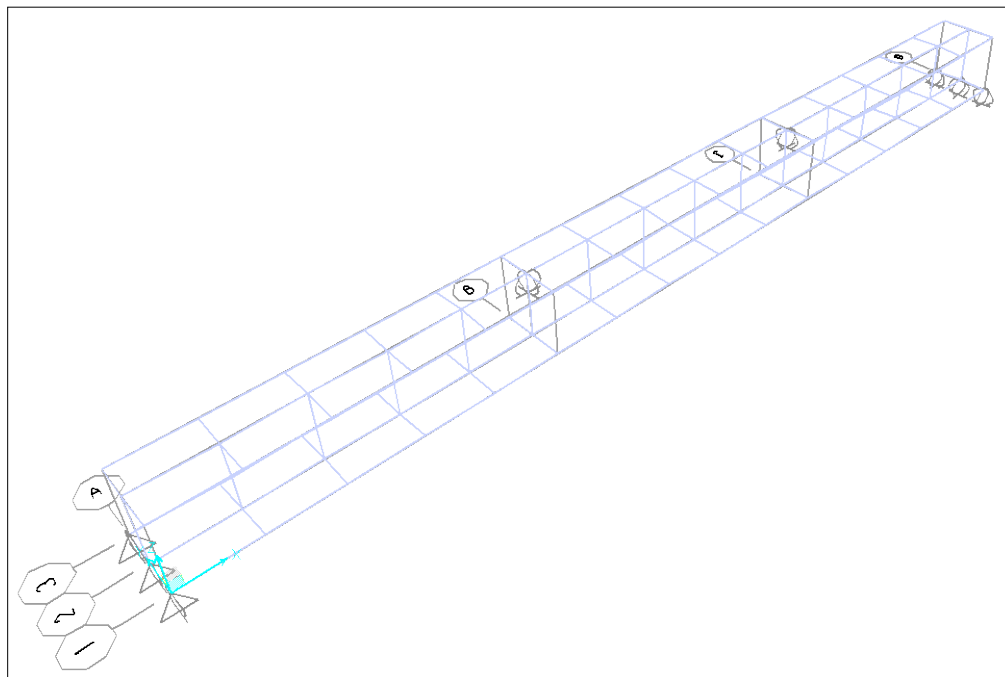
Figure 4. Finite element model for Beam Configuration #1. Model mesh as generated by SAP2000.

Output joint coordinates were established at various locations along the beam and within the cross section. Each section had seven possible output coordinates: three along each flange, and one in the center of the web. This testing was concerned with the fibers that would undergo the most extreme conditions, so output information was accumulated from six critical sections along the beam, shown in Figure 5 and Figure 6. Each beam section, with its distinct coordinates, is identified in Figure 7–Figure 12. In Table 2, the global coordinates of each joint are specified, based on the joint's location with respect to the x, y, and z axes.

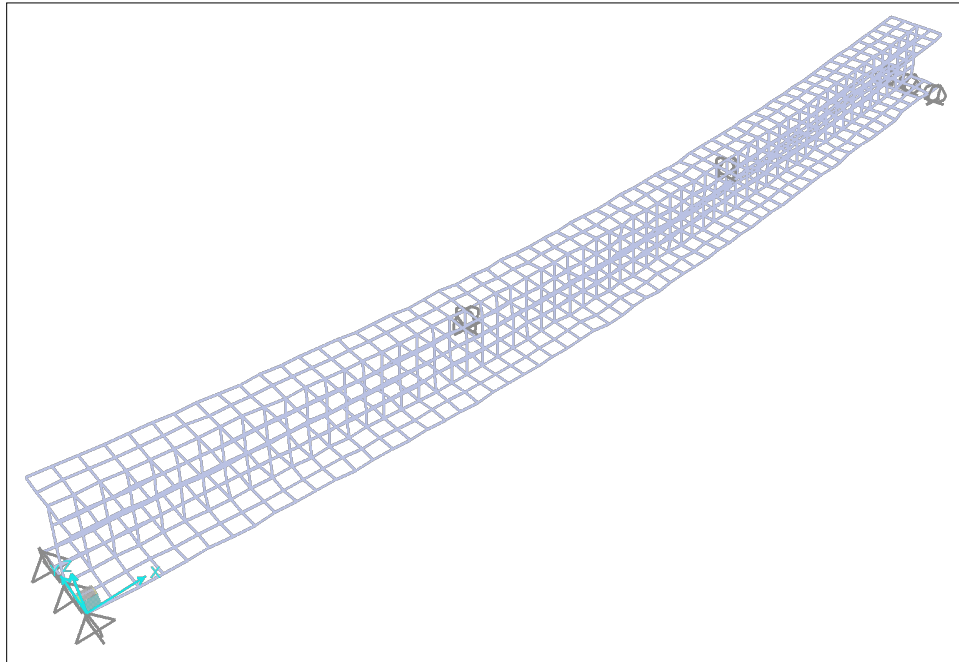
Figure 13. Deformed shape.

Loading information, as applied to the model, represented the loading conditions during Beam Test #1. In the model, the beam was restrained at both ends (pin and roller) and loaded at two points symmetrically along the beam, each point 45 in. from the center line of the beam, as shown in Figure 13. A dead load displacement of 4.0 in. was applied in the negative Z direction at each loading location. A self-weight multiplier of 1.0 was used to account for the weight of the beam. Shear and moment were established based on the applied displacements.

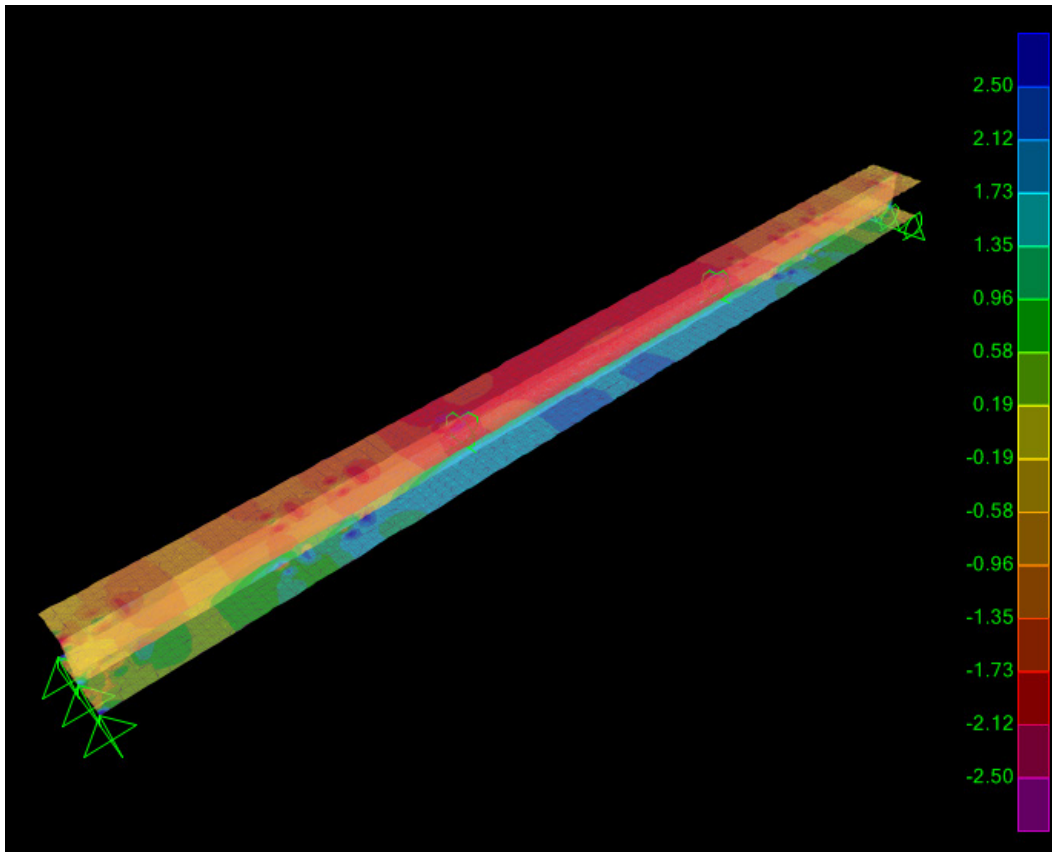
Figure 14. Spectrum of maximum stresses in the beam.

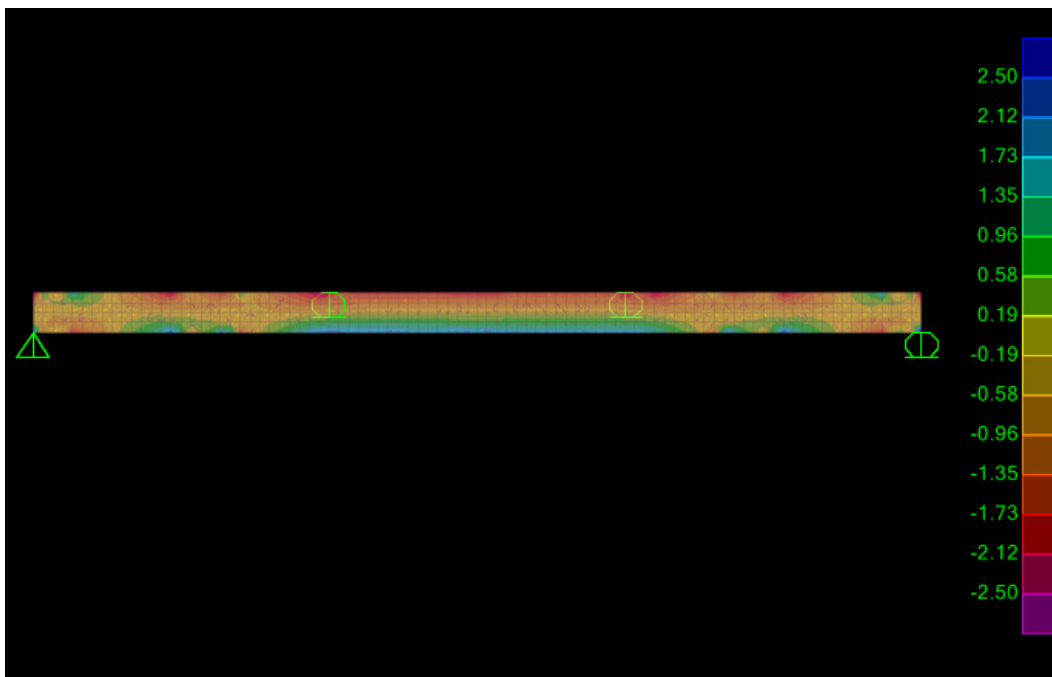
Figure 15. Spectrum of maximum forces in the beam (elevation).

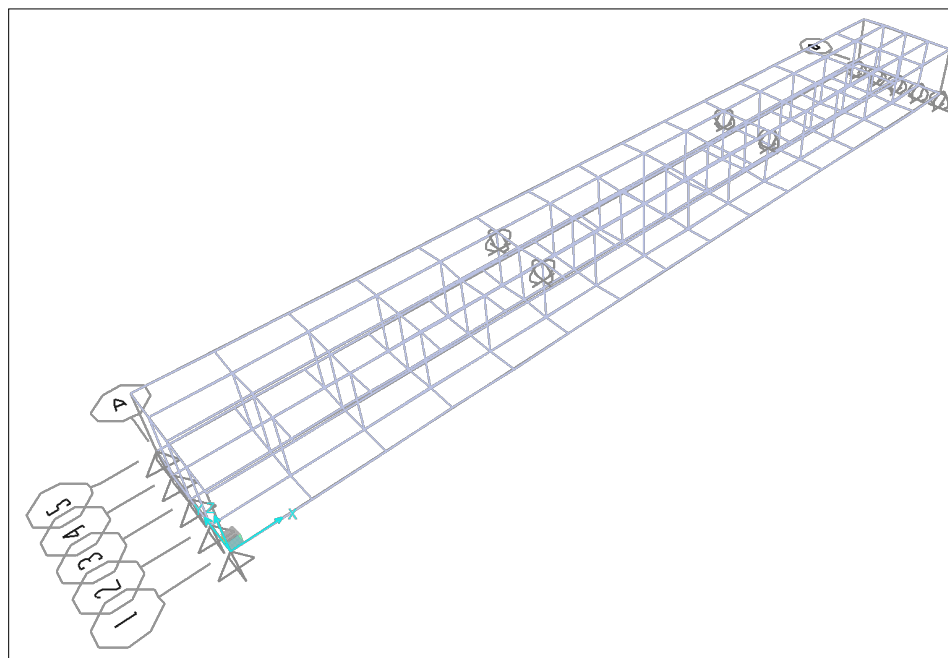
Figure 16. Finite element model.

This section describes the analytical SAP2000 models created for Beam Configuration #2, which is used to identify the typical reactions of each beam under testing conditions. This model was derived from the testing conditions and limitations of the beam, and the model allowed us to validate the true behavior of the beam under these conditions.

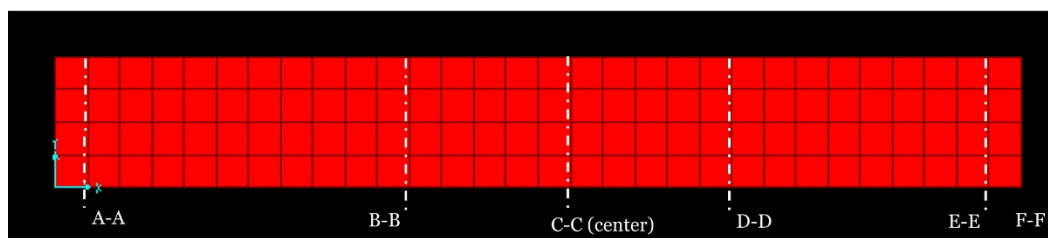
Figure 17. Beam plan indicating critical sections (z=18 in.).

The double beam was constructed by fastening two single beams together through their webs. The cross section can be seen in the Figures below. Additionally, thermoplastic stiffeners were included in the model at 9-inch spacing throughout the interior cavity of the double beam. Joint coordinates were established based on cross sections taken at various locations along the beam. Each section had 12 coordinates: five along each flange and one in the center of each web. For testing, a concern was that the fibers would undergo the most extreme conditions, so we accumulated output information was accumulated from six critical sections along the beam shown in Figure 17 and Figure 18. Each section, with its distinct coordinates, is identified in Figure 19–Figure 24. In Table 13, the global coordinates of each joint are specified based on its location with respect to the x, y, and z axes.

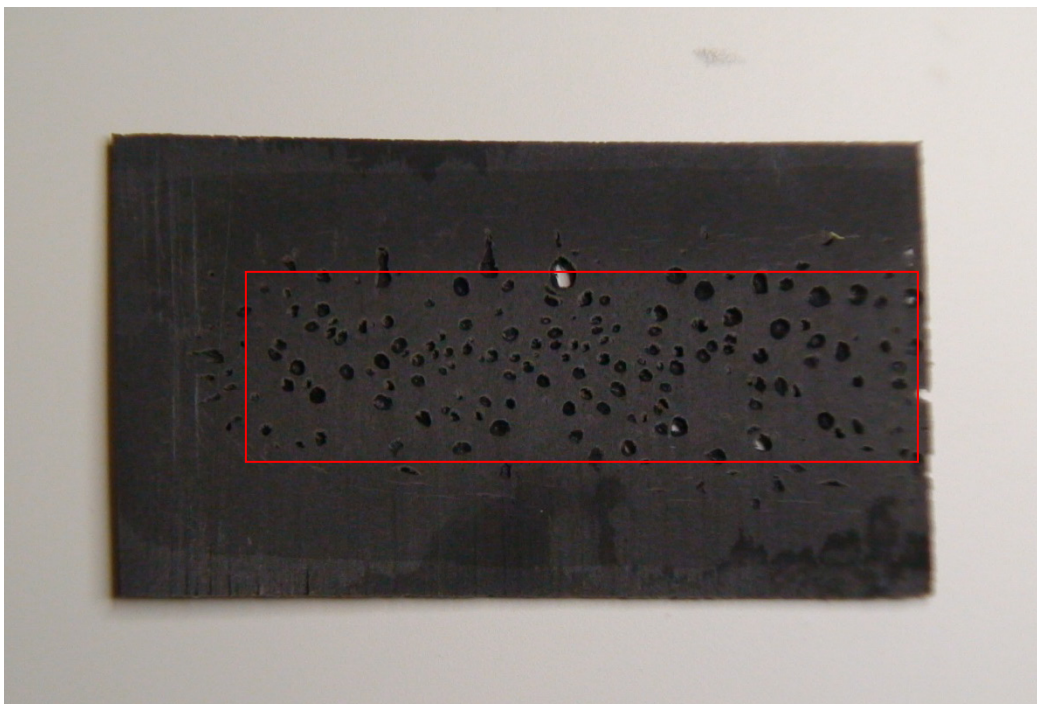
Figure 28. Typical section of extruded thermoplastic material in a web or flange, with voids in core outlined by added red box.

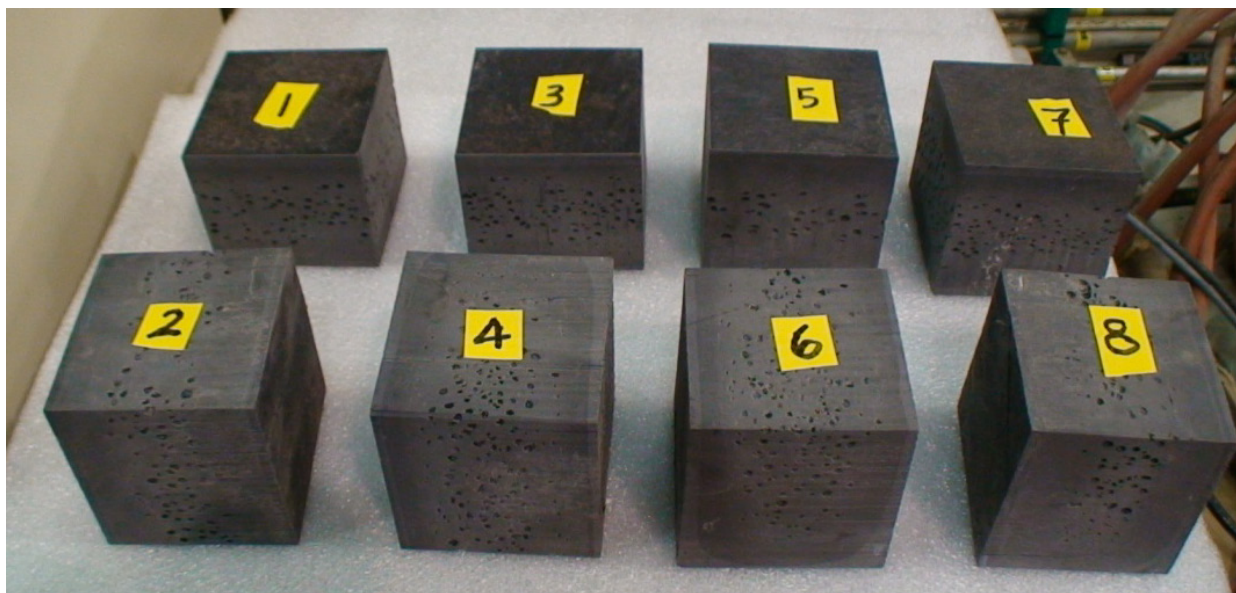
Figure 31. Prepared specimens for compression testing, with odd-numbered cubes to be loaded with layers in series, and even-numbered cubes to be loaded with layers in parallel. (Specimen No. 9 is not shown in this photo.)

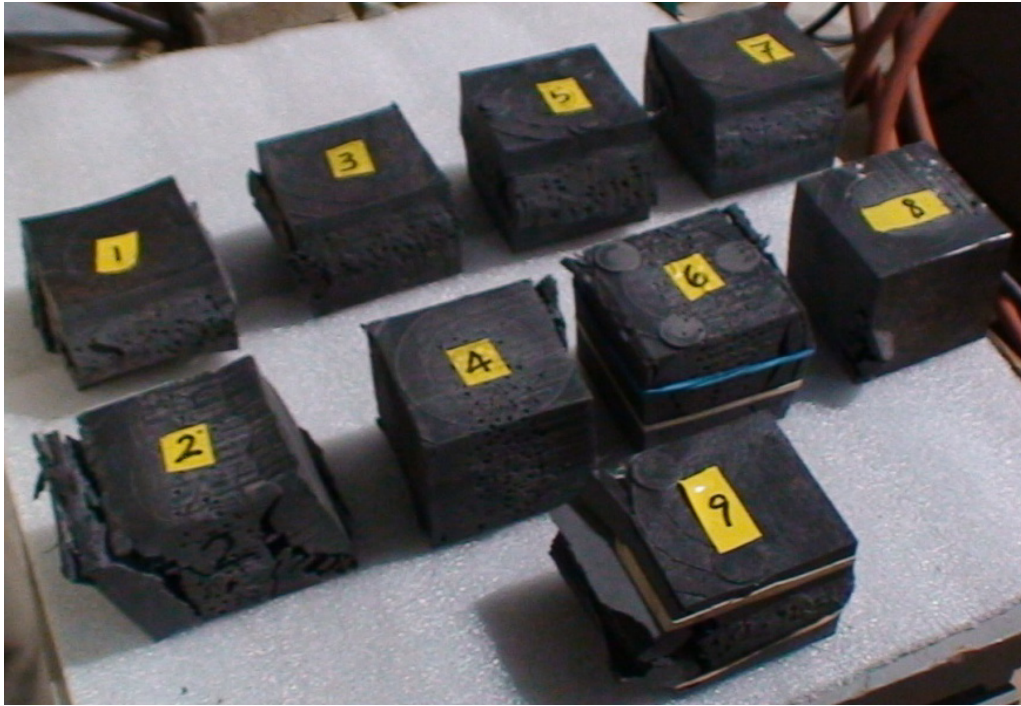
Figure 32. Specimens after compression testing.

Figure 32 shows all specimens after testing. Figure 33 shows a specimen in the Test Mark compression machine, which was used to apply a ramped displacement load to each compression specimen and to measure the corresponding force. An extensometer was also used to measure strain during testing of selected specimens (#7 and #9; Figure 34).

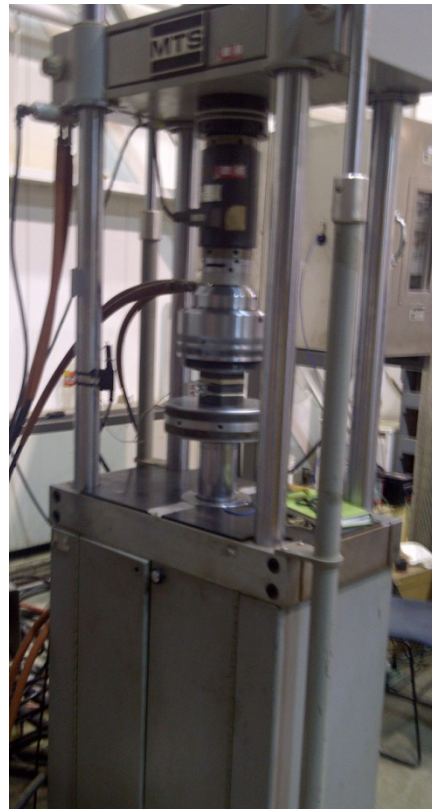
Figure 34. MTS 50-kip extensometer used to measure loading curves.

The strain values at maximum load in specimens #7 and #9 were measured by using an extensometer, to be 0.109 and 0.098 in./in. respectively. The average strain for the two specimens at ultimate strength was 0.104 in./in. Figure 35 and Figure 36 show specimen #9 before and after testing with an extensometer.

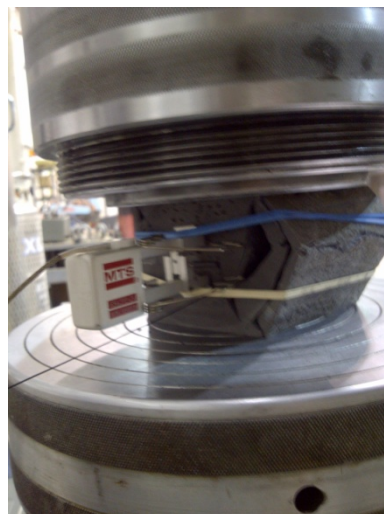
Figure 36. Specimen #9 after testing with extensometer.

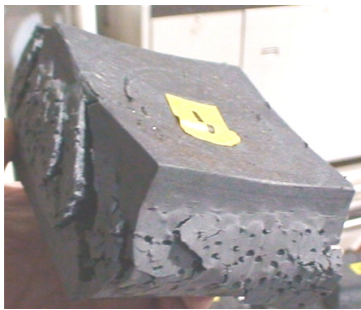
Figure 37. Cube-shaped specimens, showing modes of failure under compression load.

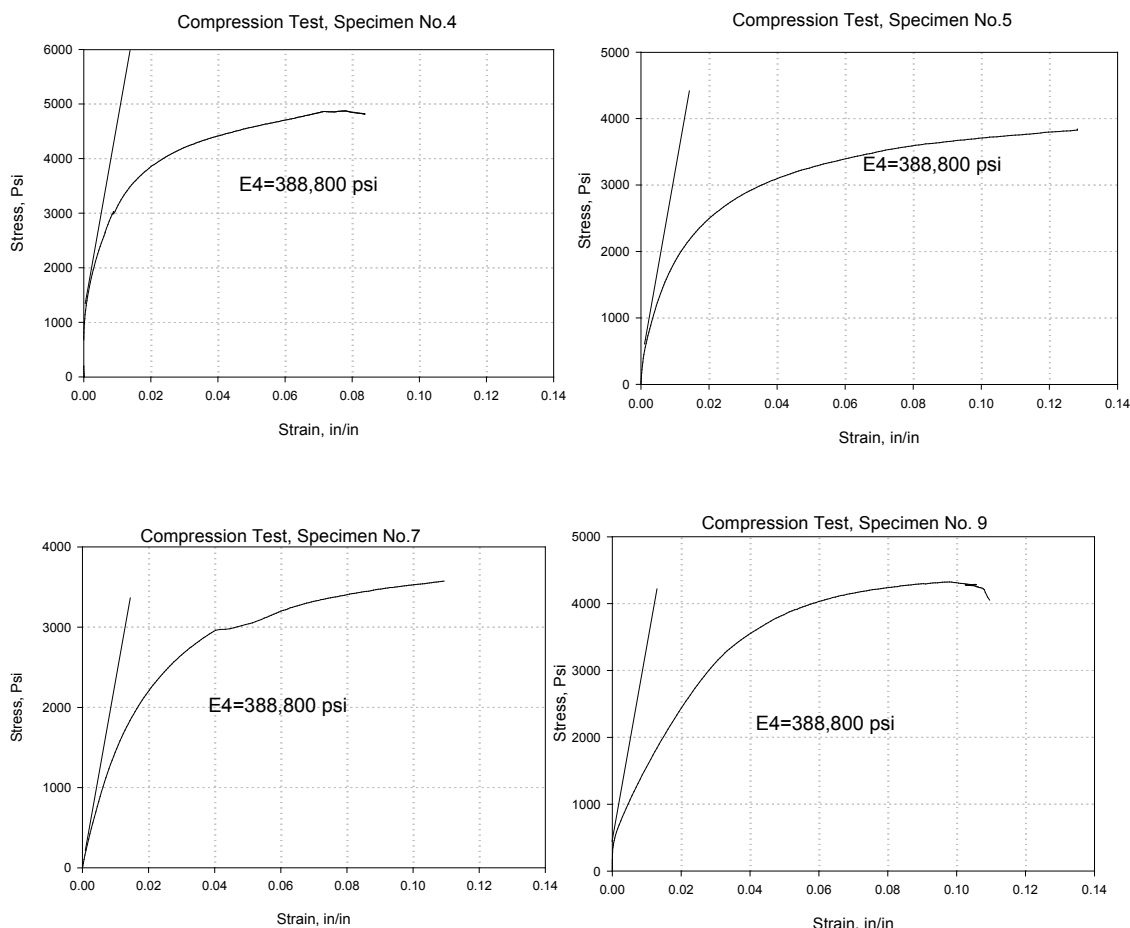
Figure 38. Stress-strain curves for several specimens.

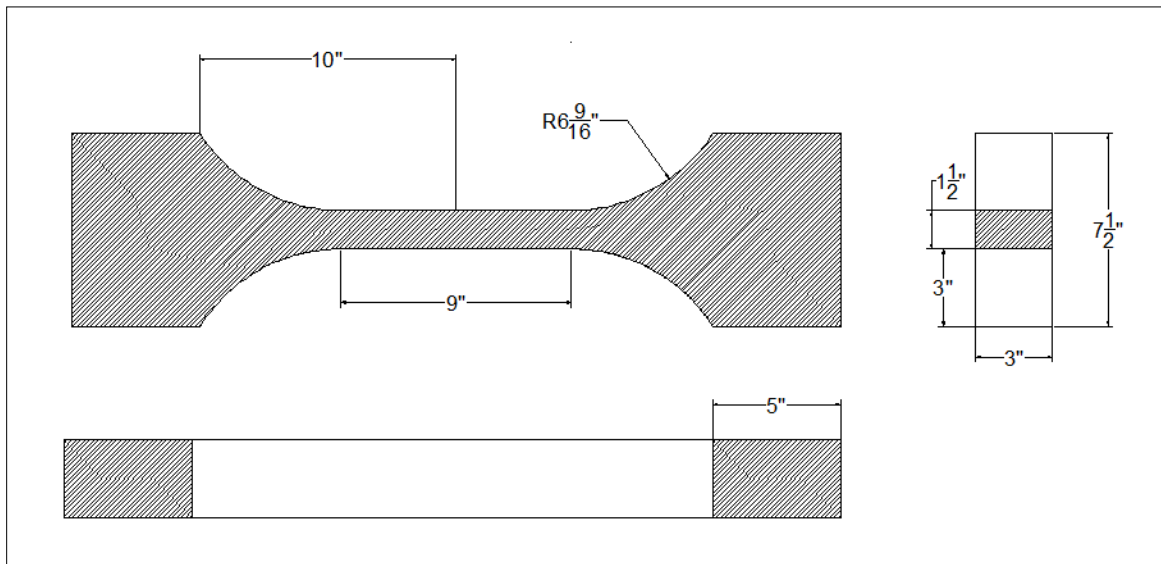
Figure 39. Nominal dimension of machine-cut dog-bone tension specimens.

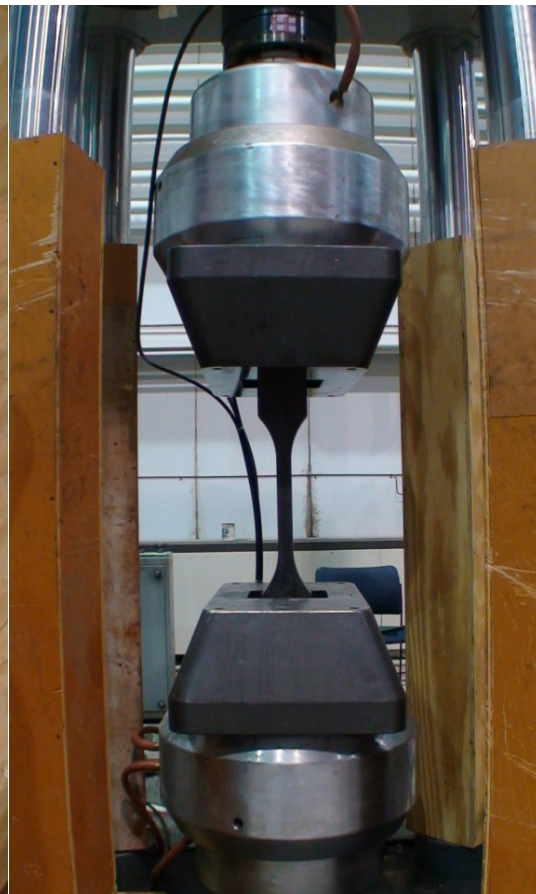
Figure 41. Dog bone mounted in MTS million-pound machine.

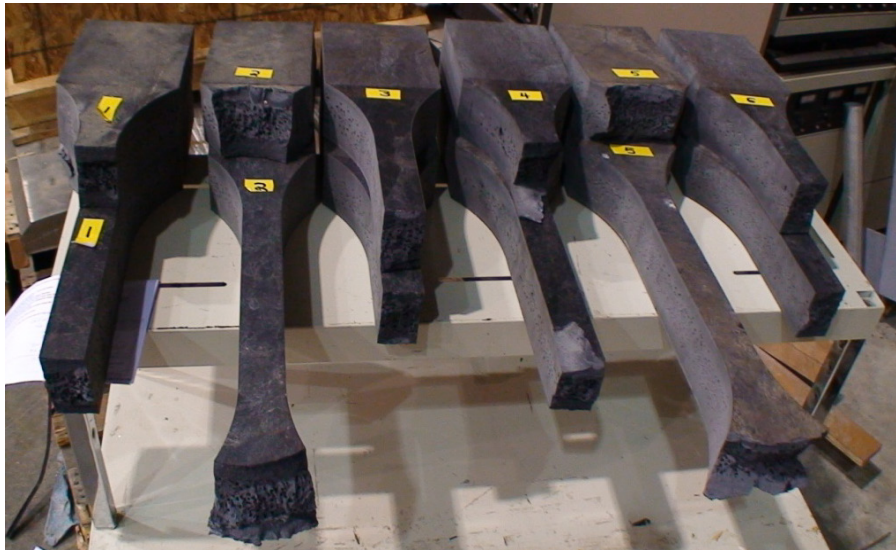
Figure 42. Modes of failure for dog-bone specimens.

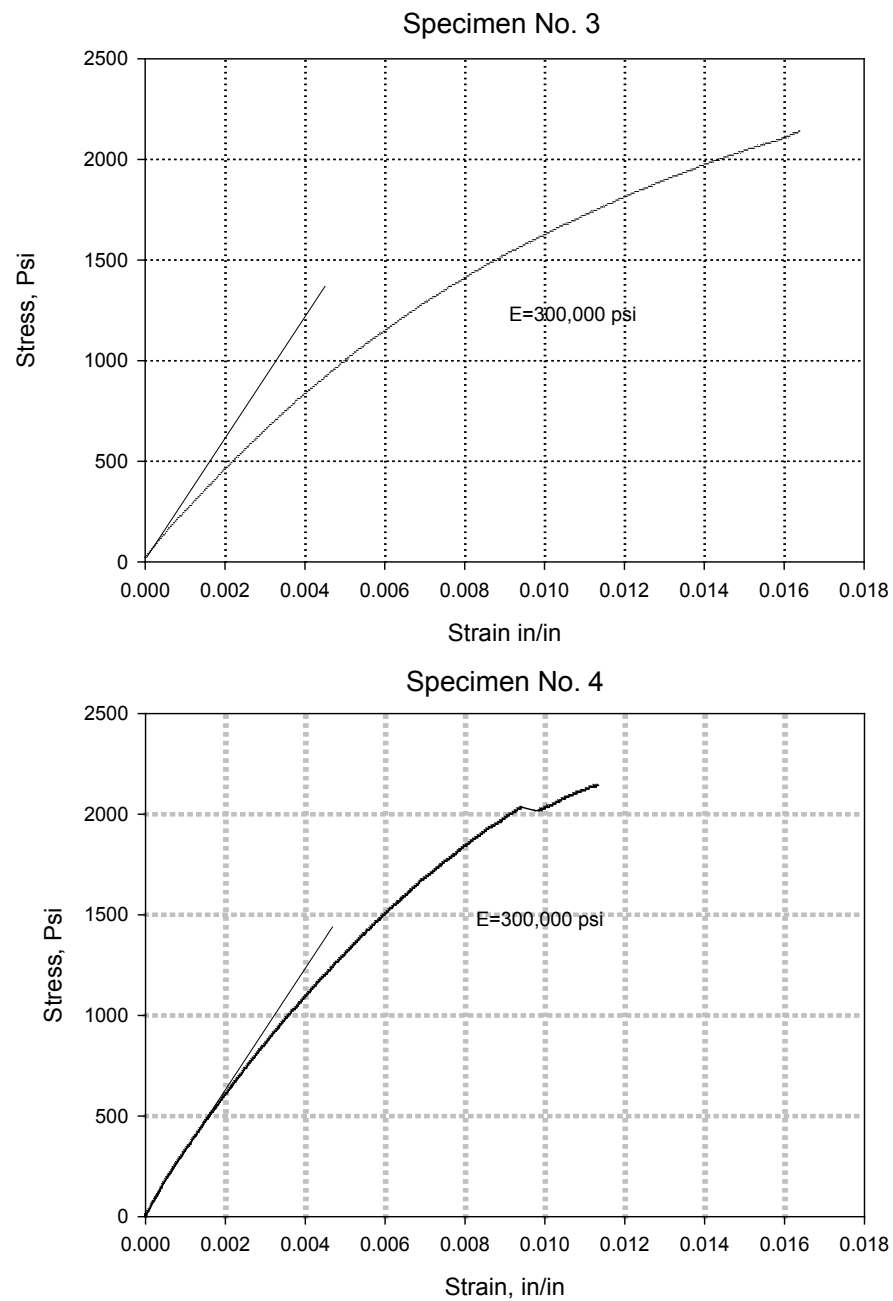
Figure 43. Stress-strain curves for selected specimens.

Tension test results are summarized in Table 25, with “bad test” failures shaded in gray. The average tensile strength is 2,059 psi, based on specimens #1, #3, #4, and #6. An extensometer was used to measure the strain at peak strength of specimens #3 and #4, which were found to be 0.0164 and 0.0113, respectively. Strains reported for specimens #1 and #6 were measured by the MTS machine. These values are not as accurate as those measured directly with the extensometer. Stress-strain curves for specimens #3 and #4 are shown in Figure 43. From these measurements, the tensile modulus of elasticity can be estimated to be about 300 ksi.

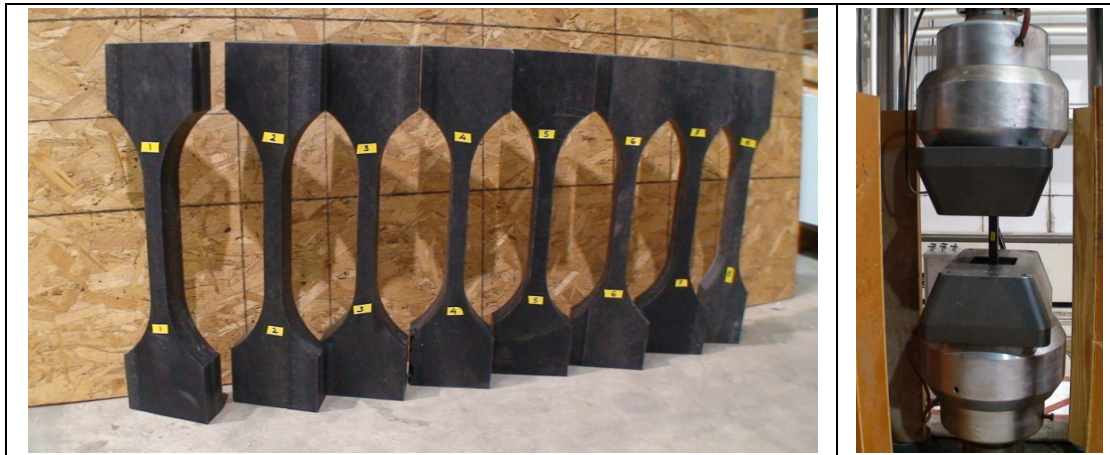
Figure 44. Dog-bone tensile specimens, improved batch.

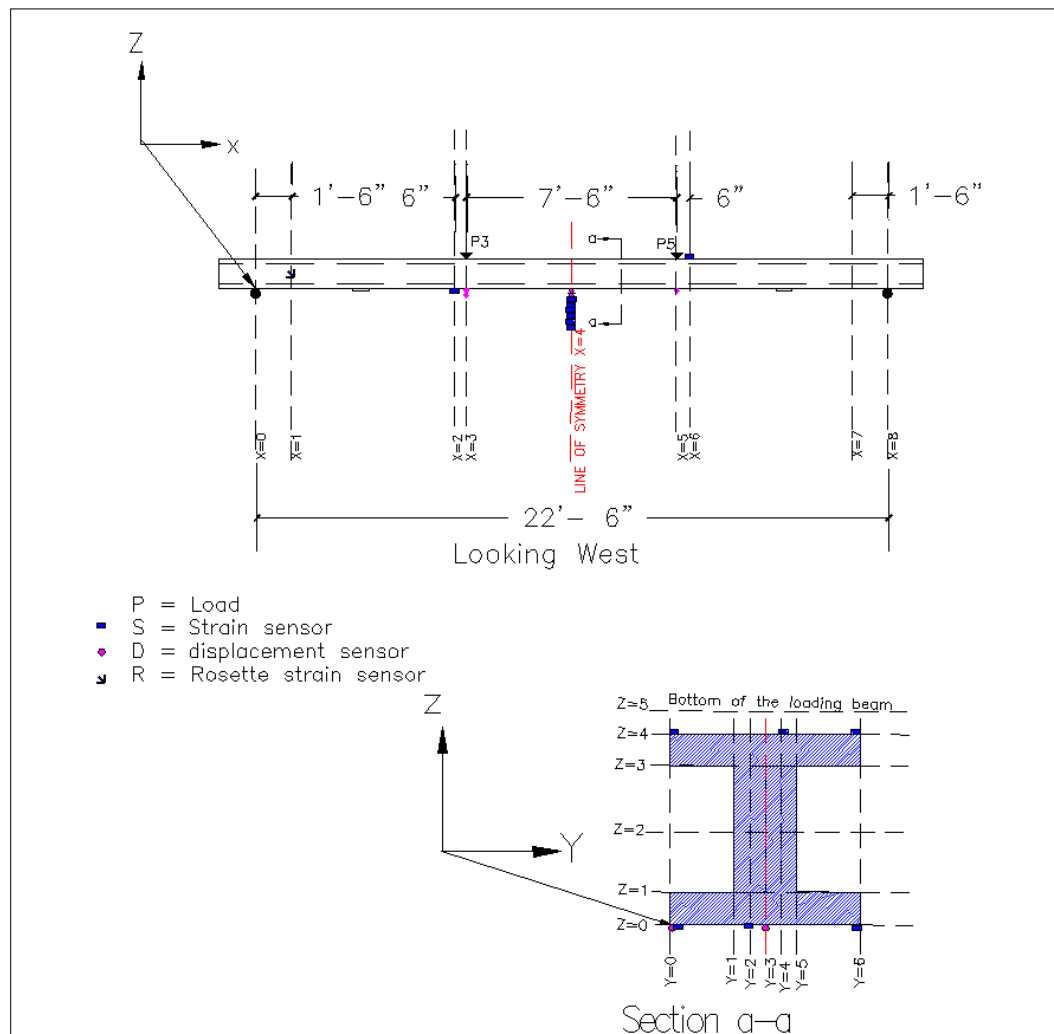
Figure 49. Strain and displacement sensor locations for the single beam tests.

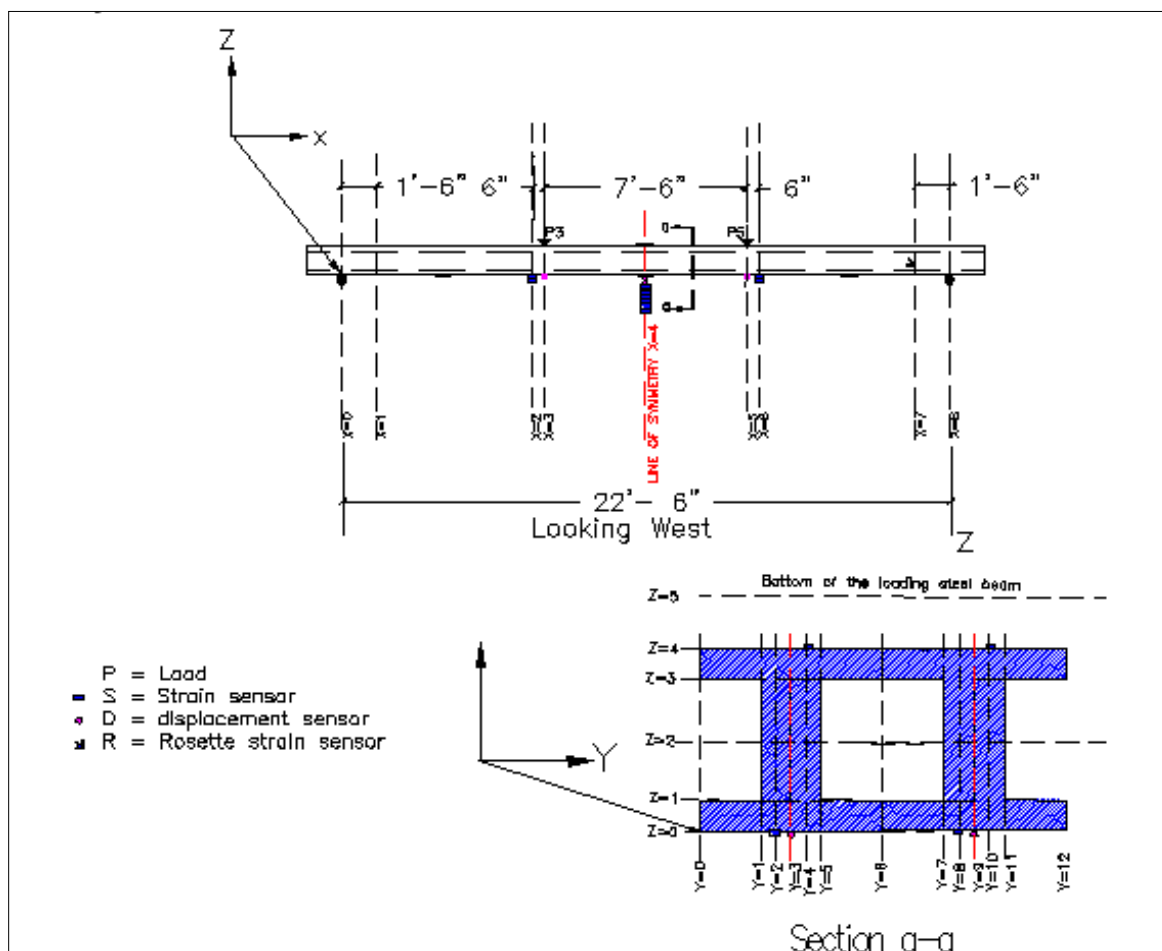
Figure 50. Strain and displacement sensor locations for the double beam (I-beam) tests.

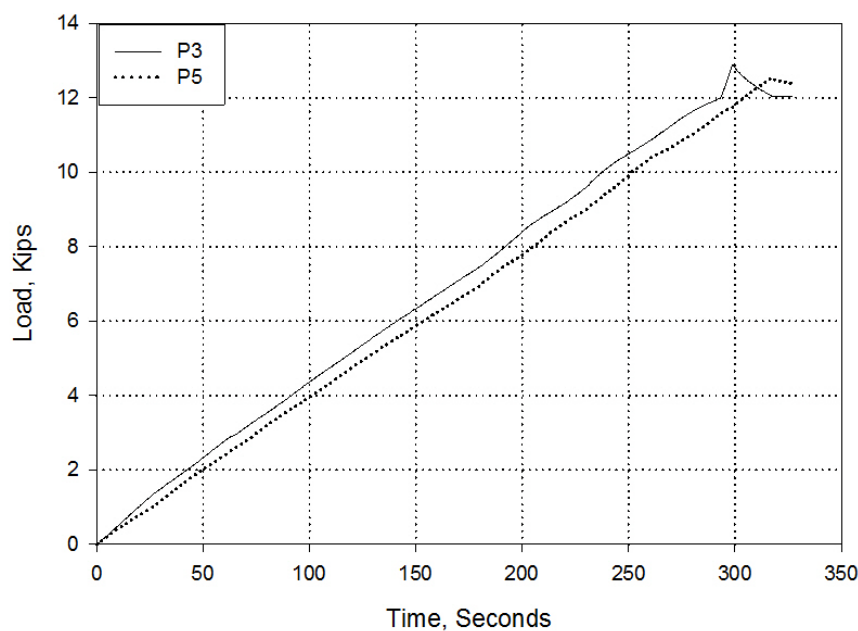
Figure 51. Actuator load versus time.

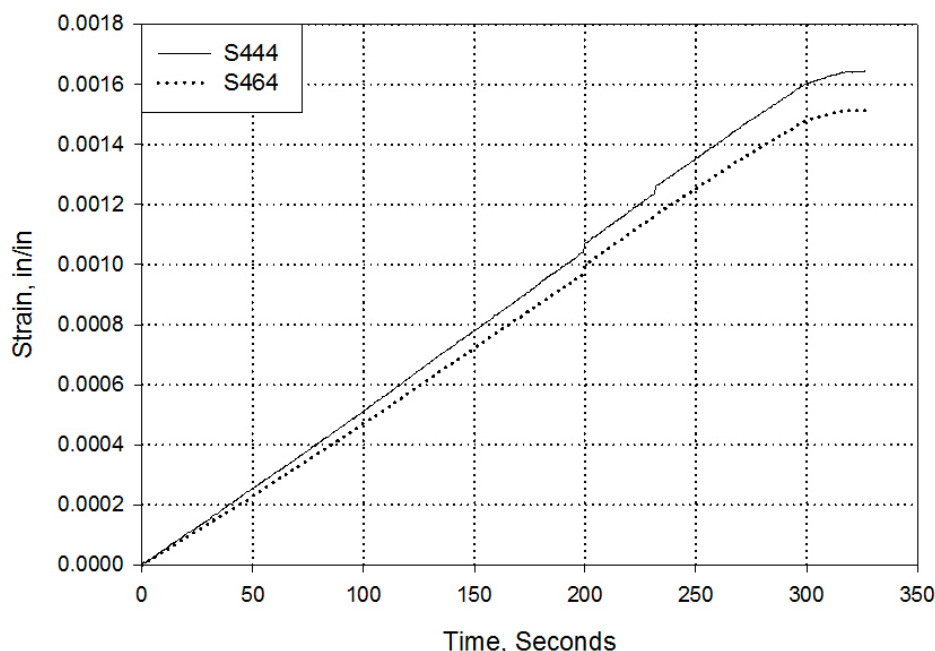
Figure 55. Magnitude of measured strains at midspan top fiber.

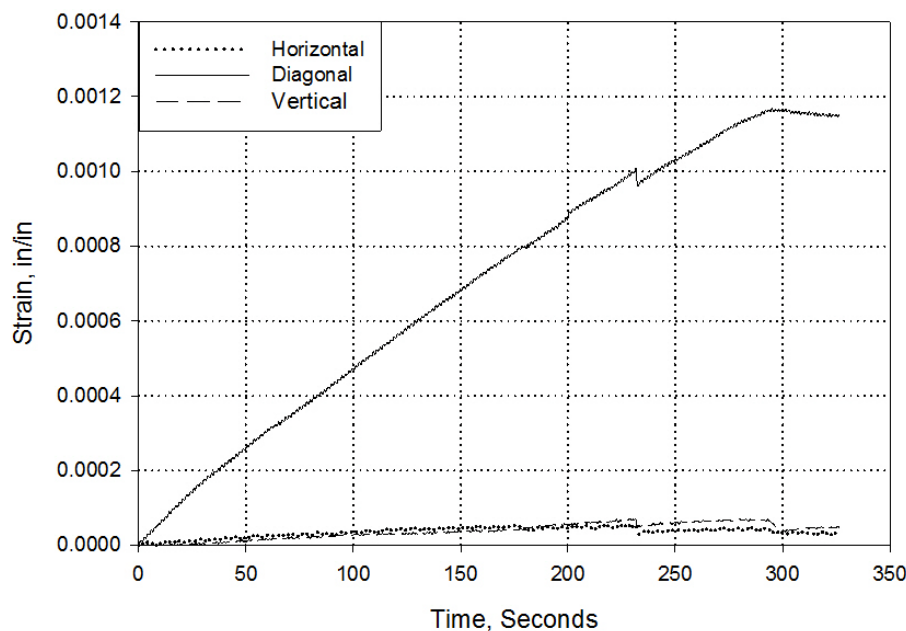
Figure 56. Magnitude of measured strain from gauge rosette versus time.

A rosette strain gauge, R₇₁₂, was installed at the section midheight, 18 in. from the north support. This is a location with high shear stress and low flexural stress. The diagonal strain gauge recorded the highest values, as expected, while the flexural-induced horizontal strain was small. The recorded vertical strain was also small. Figure 56 shows the curves of all three gauges in the rosette strain gauge. The maximum strain recorded in the diagonal gauge (ϵ_d) was 0.0012 in./in., or about two-thirds the recorded maximum flexural value of 0.0018 in./in. This shows that, while failure may be dominated by flexure, the beam experiences significant shearing action.

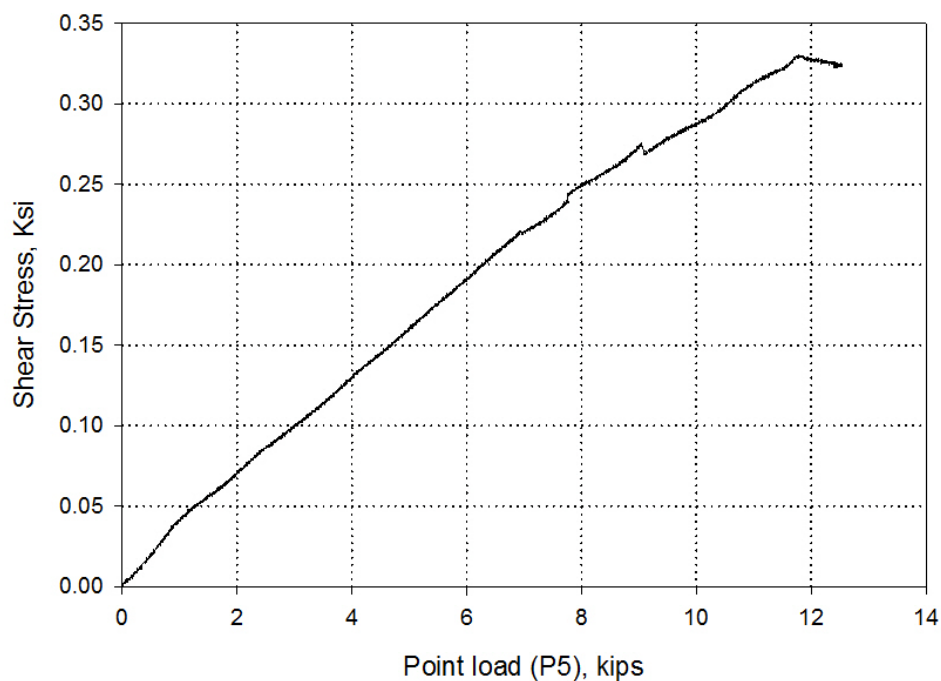
Figure 57. Shear stress at R_{712} versus point load P_5 .

Shear stress can be approximated from the data recorded by the rosette strain gauge that consists of three strain gauges: one horizontal (ϵ_h), one vertical (ϵ_v) and one at a 45° diagonal (ϵ_d).

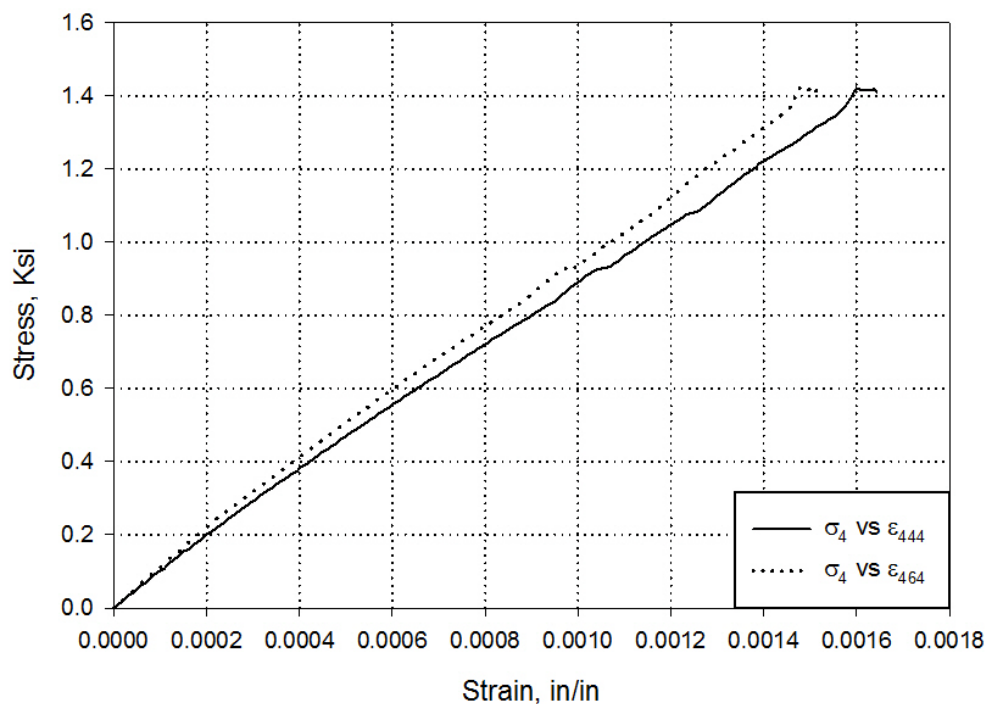
Figure 59. Magnitude of stress-strain curve at midspan, top fiber.

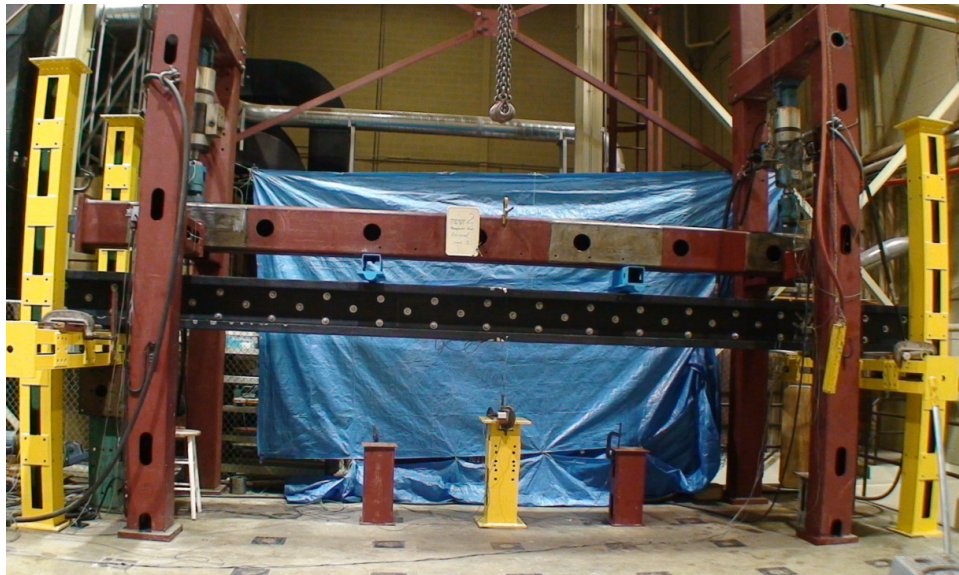
Figure 61. Test #2 setup.

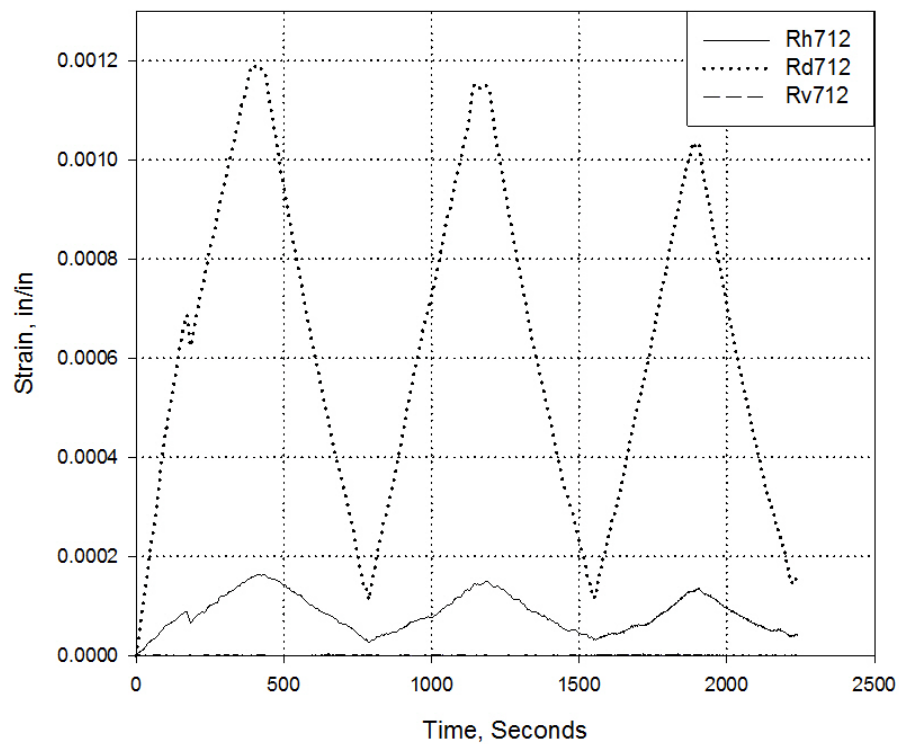
Figure 67. Strains measured with R₇₁₂ versus time.

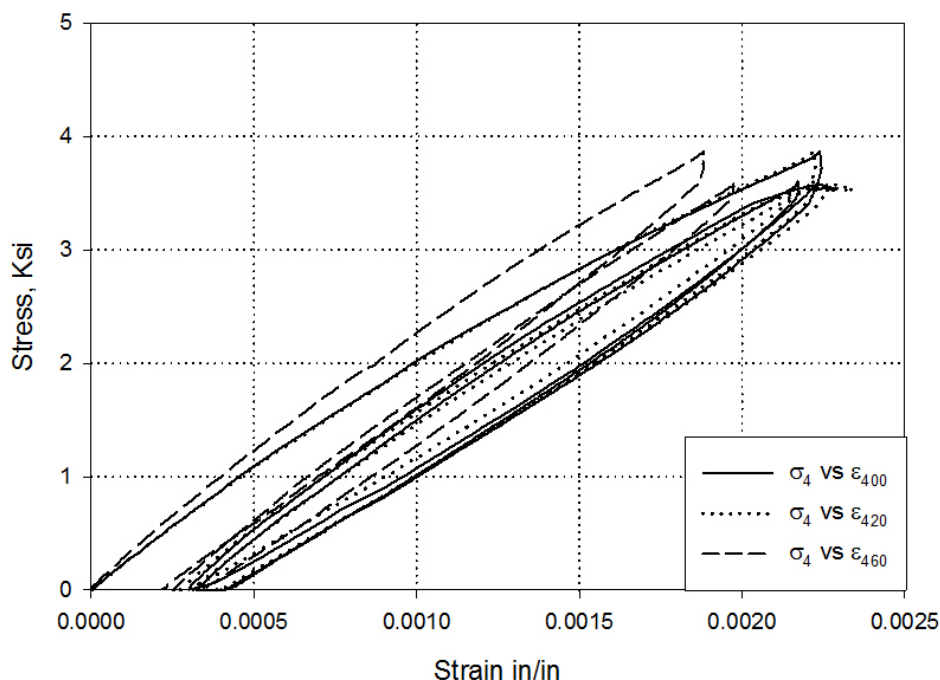
Figure 69. Stress-strain curves at midspan bottom fiber.

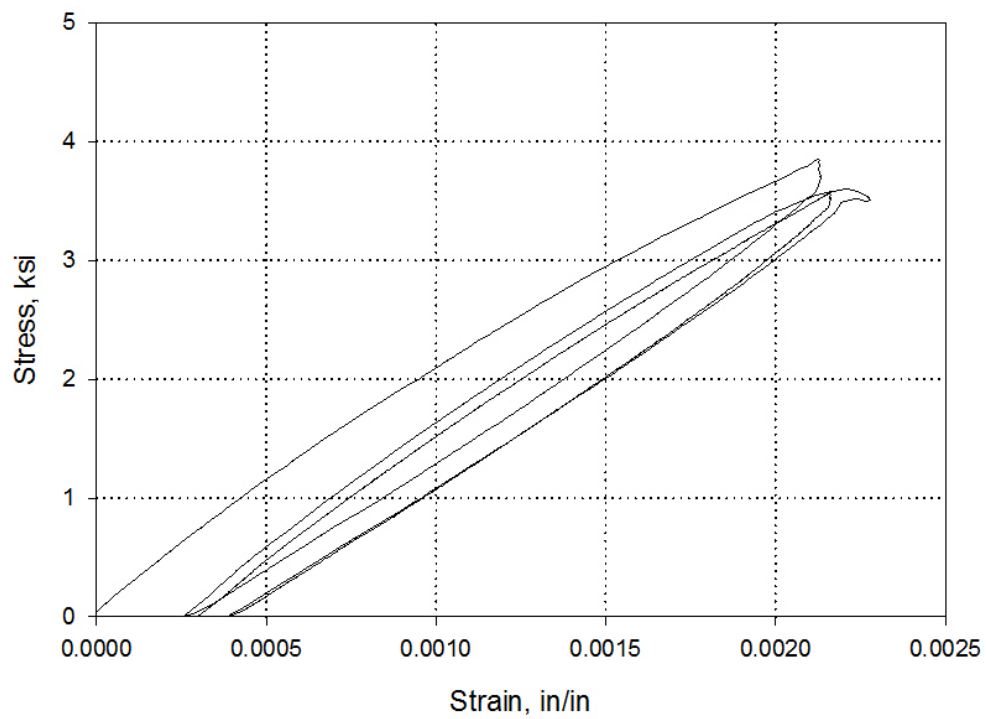
Figure 71. Stress-strain curve at S₆₃₀.

Strain gauge S_{630} was installed at a section 6 in. (in the x-direction) from the point load. This section was chosen for its high shear and flexural stresses. It is unlike the section located 18 in. from the support, which was instrumented with rosette R_{712} . That location has a high shear stress and low flexural stress. The stress-strain curve for the location of S_{630} is shown in Figure 60.

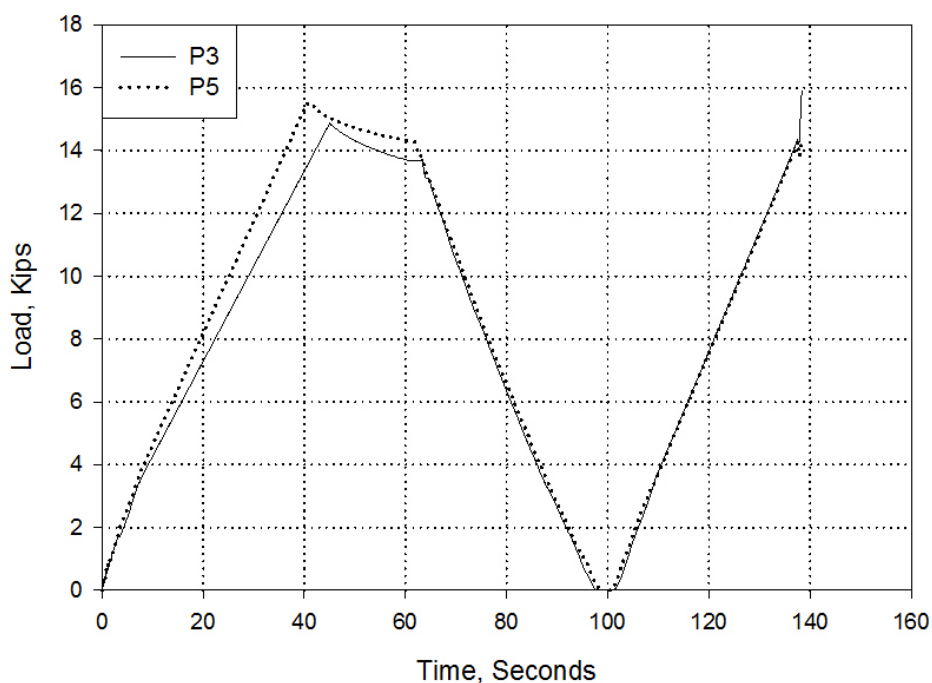
Figure 72. Load in actuators versus time.

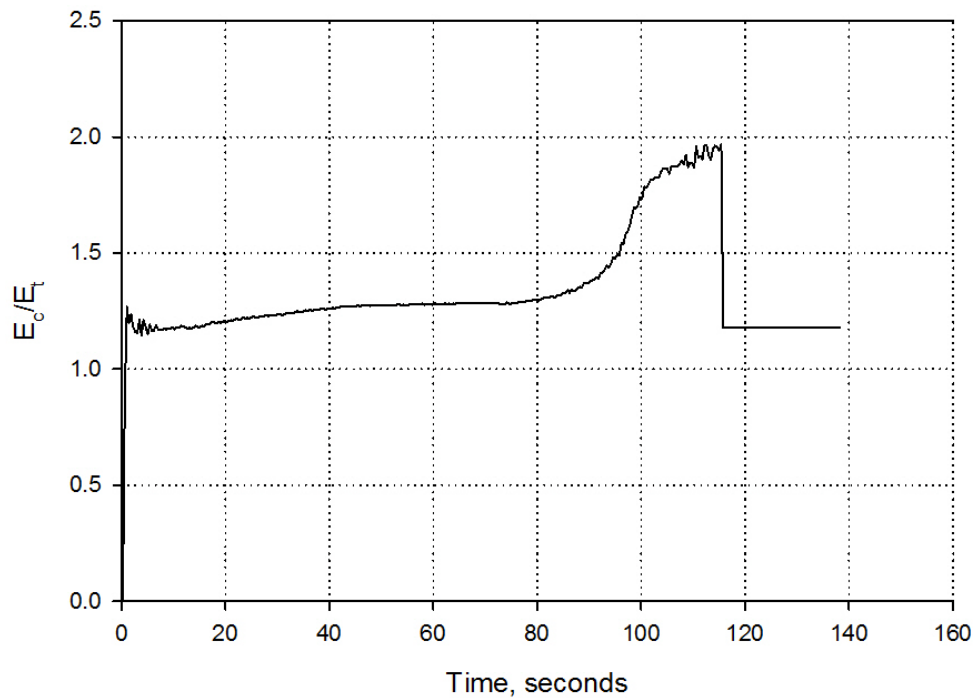
Figure 75. Estimated variation of relative compressive and tensile stiffness of thermoplastic, plotted over time.
